Project **Wastewater System Improvements Project - Alternative 2**  
 Owner **Village of Three Oaks**  
 Date **April, 2023**

**Collection System Improvements**

**RE: WASTEWATER COLLECTION SYSTEM ASSESSMENT REPORT**

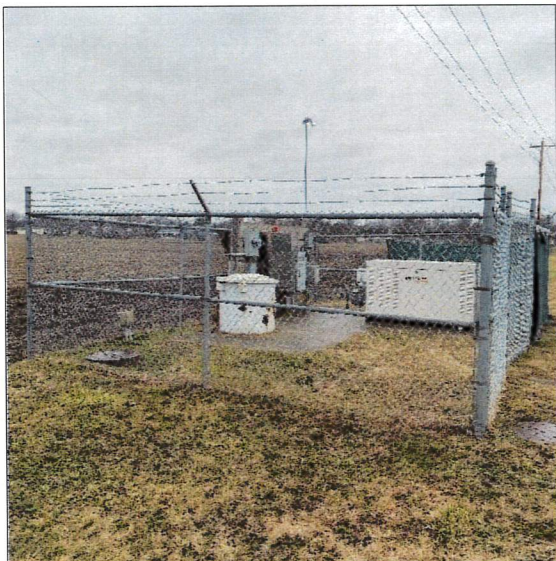
Figure 1 - Highway Lift Station

Station	Pump Design Capacity (gpm)	Pump 1 Test Rate (gpm)	Pump 2 Test Rate (gpm)	Wet Well Condition	Pump Condition	Electrical & Controls Condition	Generator Condition
Highway	180	150.3	169.1	Good	Fair	Fair	Good
Swan Song	20	18.8	15.0	Good	Good	Good	N/A

The Highway Lift Station located on US-12 conveys wastewater flows from the residential areas in the southeast section of the Village. Minor improvements have been completed at the station since it was constructed in 1970, and cyclical pump replacements and replacement of the control panel are needed at this time. Additionally, we recommend telemetry improvements be completed at both the Highway Lift Station and Swan Song Lift Station, such as the addition of Mission Control panels, to improve station monitoring and increase system reliability.
